WIND UPLIFT EFFECTS
ON BUILDINGS

The following case study describes Pario's involvement in the structural engineering investigation of roof structural failure of a federal building (a brand new military aircraft hangar) that occurred during an exposure to a wind storm on December 28, 2008.

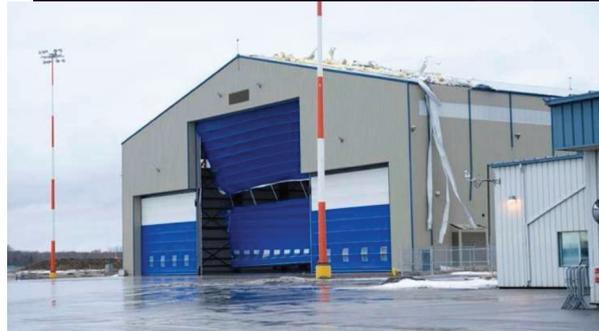
Figure 3. The hangar within hours after the incident.

It was reported that during a wind storm, while the hangar doors were closed, two large areas of ruptures opened; one within the hangar roof cladding; and, the other within the huge front door. Luckily the CC-117 or any other aircraft was not stationed inside the hangar at the time of this incident. That was luck, since airborne "shrapnel" from the fractured door blew 50 meters inside the hangar. The largest piece of shrapnel weighed 30 pounds.

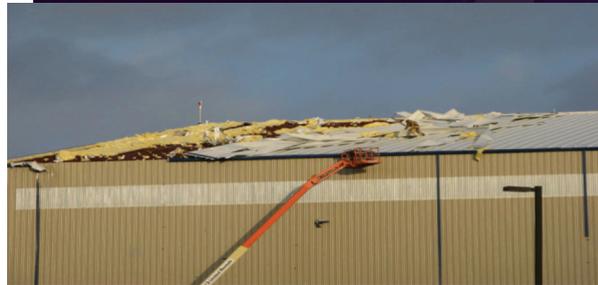
Figure 4. Area of roof rupture. Emergency crew in action.

The ruptured roof area was about half of the overall damaged roof deck area, which itself was roughly 1,100 square meters (11,860 s.f.). The exterior wall cladding adjacent to the damaged roof was also damaged (400 sq. m.). Within one location there were several buckled or bent eave struts and a wall girt. These were damaged due to the whiplash force that the airborne roof decking produced on that location of intersecting roof and exterior wall. The primary structural members of the hangar (e.g. columns, main roof girders) were not adversely affected by the loss. A large part of the door middle section (567 sq.m.) and its attachment to the vertical door mullions (supported by the building columns) was damaged and displaced.

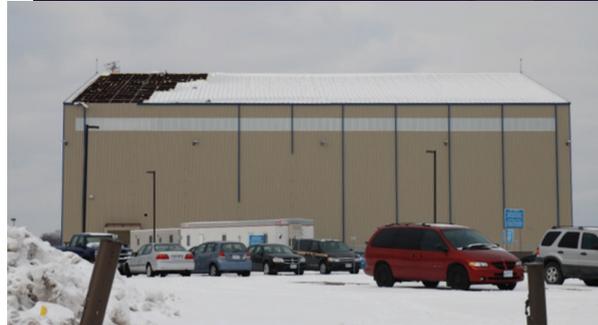
Figure 5. Damaged roof area cleared from debris.

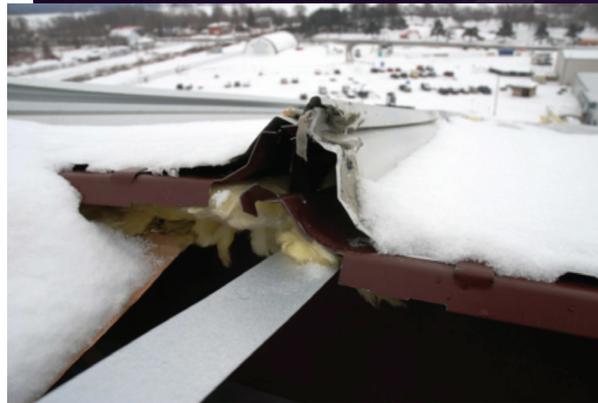
Our calculations established that the “weak-looking” component of the roof clips constructed within the roof corners failed to resist the maximum upward (pull-out) force of 1.9 kN (428 lbs), which was transferred to the subject component during the storm when the mean wind velocity reached 61 km/h. The steel of the weak component yielded when the applied pull-out force reached 1.9 kN. The steel yielding caused the hook of that component to open and to release the portion of the roof deck, which the hook was holding.

Figure 6. Damaged standing seam

Moreover, throughout the entire roof, wherever installed, that component of the roof clip was incapable of resisting the maximum design wind-uplift loading anticipated to occur in Trenton with probability of occurrence once in 50 years, as required by the 2005 NBCC (2006 OBC respectively). Not only the corner zones but the entire hangar roof cladding had to be replaced and/or reinforced.

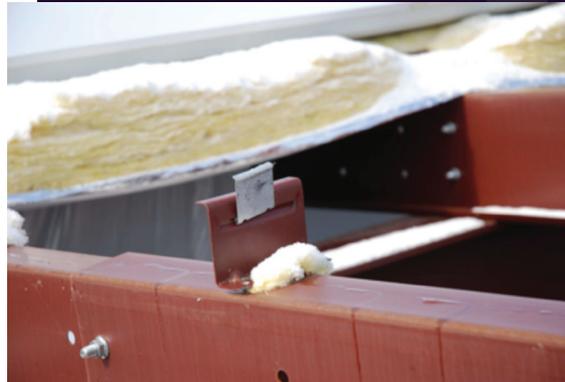
A two-component roof clip, which was used throughout the entire roof, held down the roof decking attached to the roof purlins. We grew suspicious of one of the clip components that looked “weak”. As mentioned above, a prototype of this type of the Ultra-Dek roofing assembly, which included the subject roof clip, was tested by the UL; and, therefore, the clip was allegedly adequate for the wind-uplift forces at the time the failure occurred. However, full information in regards to the materials used in the production of the roof clip components installed on this hangar was not obtained; in other words, there was not enough evidence that the installed roof clips exactly matched the ones that were tested.

Figure 7. The “weak” top component of the two-component roof clip.

The lab conducted physical testing of the maximum pull-out force that sole component was capable of resisting before opening its hook to beyond 90 degrees. The results fully confirmed our theoretical structural analysis.

National Defence Canada requested that Pario get involved with the reconstruction of the hangar roof. We checked and approved the new design for the roof cladding and since the completion in 2009 of the hangar reconstruction; the CC-177 Globemaster IIIs enjoy a safer shelter.
